Troubleshooting

This appendix explores the types of problems that might interrupt or prevent call transmission, and suggests some procedures for addressing those problems. This appendix covers these topics:

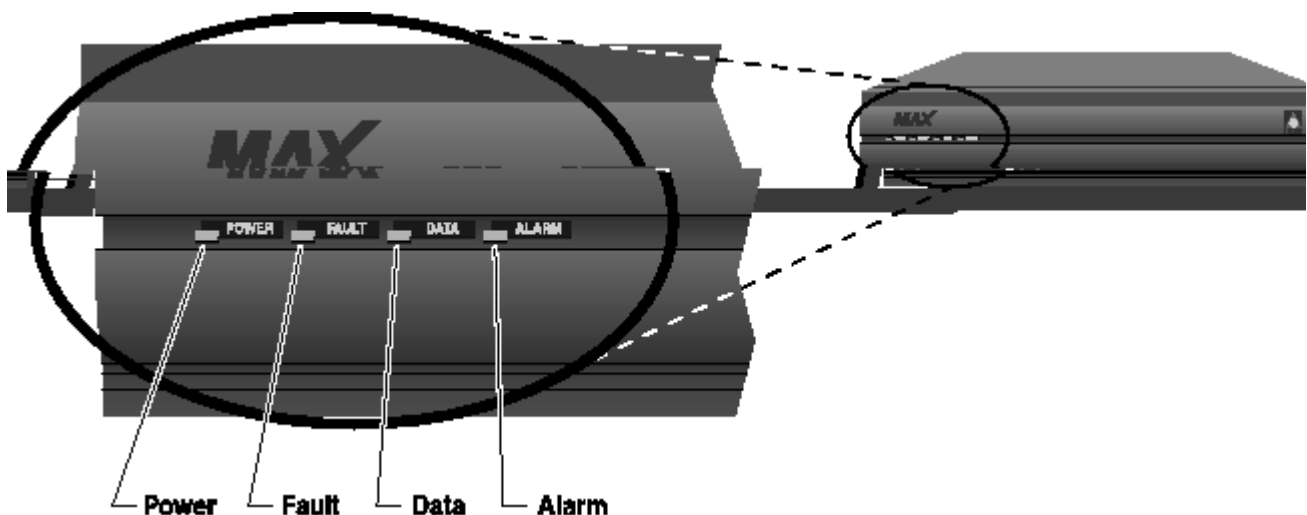
Figure A-1. MAX front panel LEDs

The MAX front panel includes this set of LEDs:

The front-panel LEDs report on the status of the system, the PRI interface, and the data transfer in active sessions.

-1 lists and describes each LED.

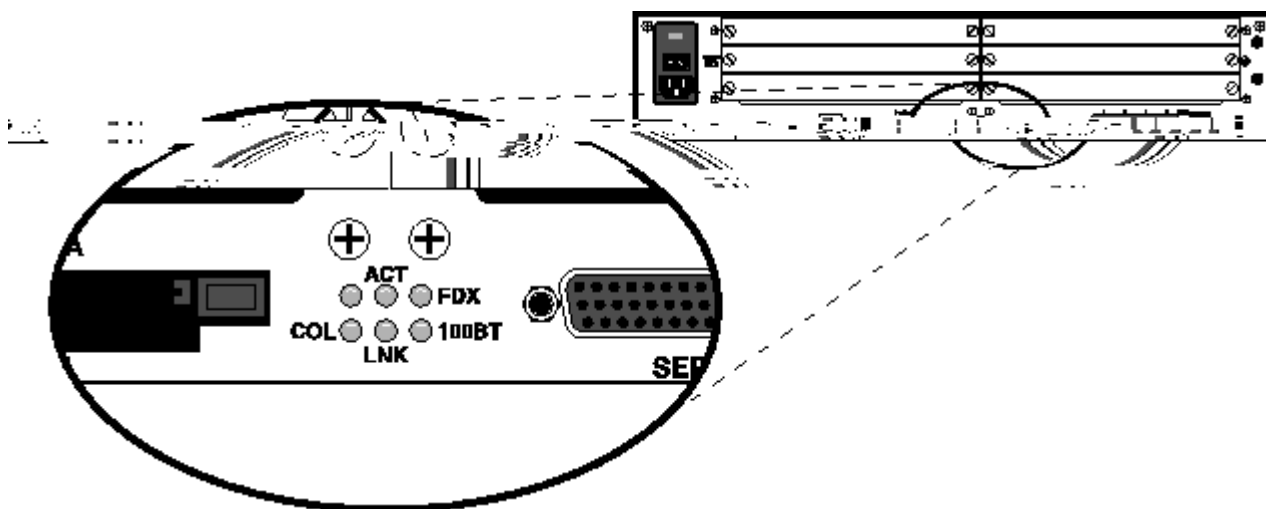
Figure A-3. Ethernet interface LEDs on MAX back panel

The MAX back panel includes the following LEDs that display the status of the Ethernet interface:

Note: The Classic MAX back panel shows similar LEDs on the Ethernet expansion card if one is installed. On the Classic MAX, there is one LED for each possible Ethernet interface (10BaseT, and COAX (10Base2), which are lit when the interface is in use. The ACT and COL LEDs are the same as those on the MAX 6000 (Table A-3).

LED	Description
ACT (Activity)	This LED is on when the MAX is detecting activity (network traffic) on its Ethernet interface.
COL (Collisions)	This LED is on when the MAX detects packet collisions on the Ethernet.
FDX	When this LED is on it indicates full duplex on the Ethernet.
100ST	When this LED is on, it indicates 100BT; when it is off, it indicates 10BT.
LINK (Link integrity)	This LED is on when the Ethernet interface is functional.

The Ethernet interface LEDs are described in Table A-3.
